Anna Henningsson

DISCOVERING THE MEANING AND THE MAKING OF A BAROQUE ALTARPIECE DURING TUNNELLING WORK

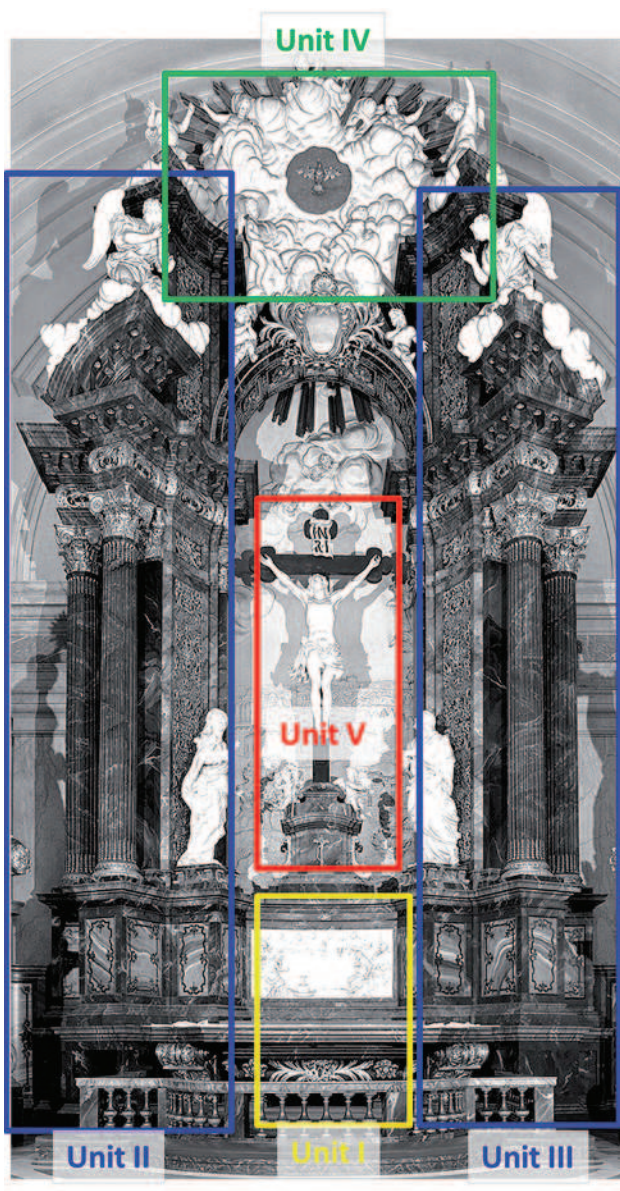
The altar consists of a system of units built up of modules. Each module consists of wooden boxes in a frame and filling system. Unit I is located in the middle of the base and predella, between unit II and III. Unit I carries the cross construction (unit V). This module is a frame construction in a vertical and a horizontal direction with an upper and lower section.

3. The location of the five constructive units of the altar structure. Photo: Fokus GmbH Leipzig.

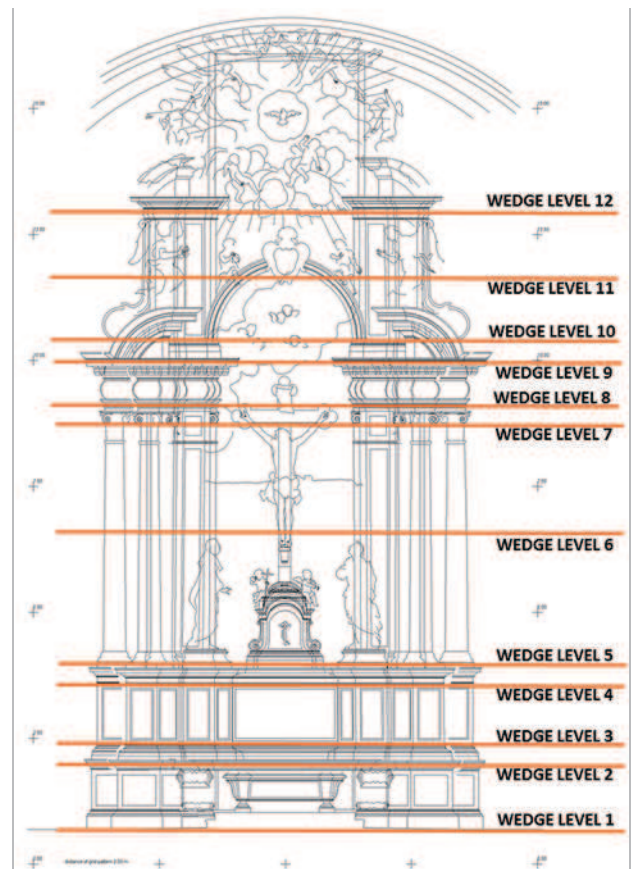
are aesthetically tied together by the arch, but without any real constructive function or unifying effect due to alterations in the original construction during the 20th century. The undertaken survey discovered a preserved locking construction of frames and wedges on 13 levels over the height of the altar units II and III. This means that there must have been seven levels of wooden modules in a vertical direction available to create the height of unit II and III. Further, this led to the need of about 38 box modules for

4. The location of the wedge levels in the modules. Photogrammetric drawing: Fokus GmbH Leipzig.

[3] There is still a need for deeper investigation regarding the frames and wedged system in level 8 and 9 as well as on level 12 and 13. In these levels in the wedged system, the alterations have been very extensive over time and an extended examination of negative traces in the structure on this level is required to establish and finally verify this assumption.

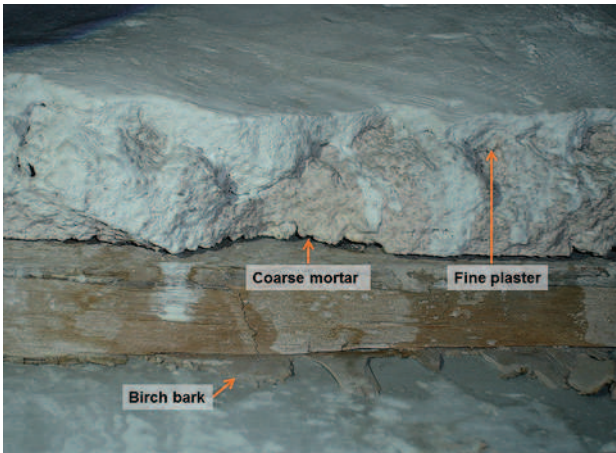
5. Layers of mortar, plaster and birch bark used in the creation of the stucco elements. Photo: Anna Henningsson.

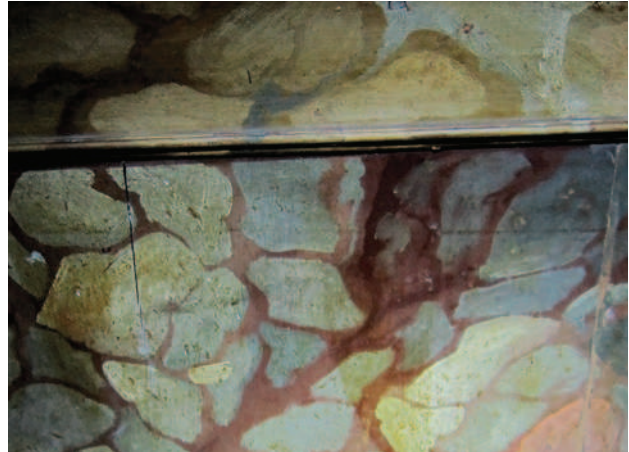
6. Details of original preserved paint of a marble imitation on the back side of the altar. Photo: Anna Henningsson.

The wood is painted to imitate various types of stone in colours of red, brown, green and blue. Carved wooden ornaments are provided with layers of unidentified metal applications, this was in order to imitate metal and enhance lighting effects, as was highly desired at the time that the altarpiece was created. Most of the backside of the altarpiece

has its original marble-imitating paint well preserved. Different layers of white surface treatments from different times cover the stucco in the altarpiece.

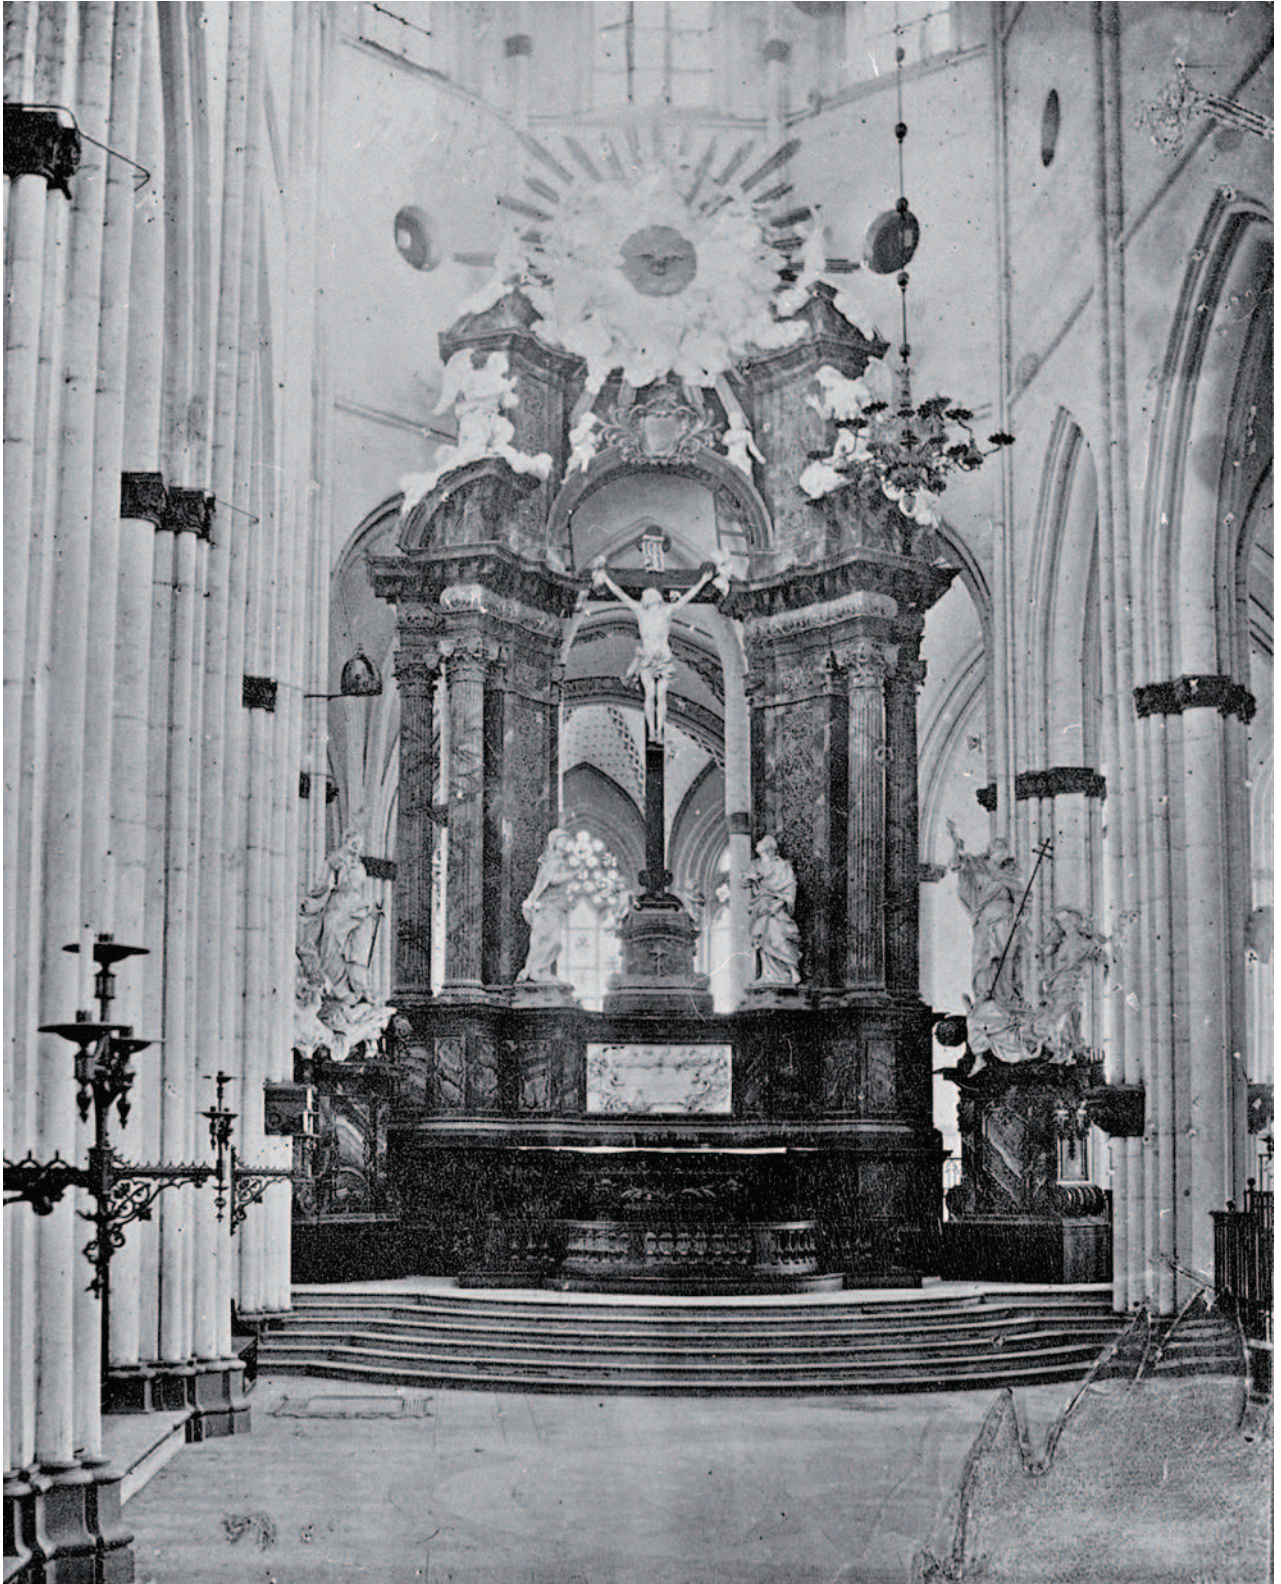
7. The altarpiece on its original location in Uppsala cathedral before 1885.

From the outside, only a few alterations to the altar are visible. The major alterations have been made inside the altar, which has impacted the whole construction. This has been ongoing for almost a hundred years. A visual comparison of archival photographs shows that the lowest part of the base, as well the uppers parts, the rays in the cloud, were sawn off in 1905, when it was realized that the altar was too high for the choir in Gustaf Vasa church. In Uppsala, the cross was positioned in line with the entablature. In the Gustaf Vasa church, it was shortened and given a lower position in the arch (compare fig. 1. and 7).

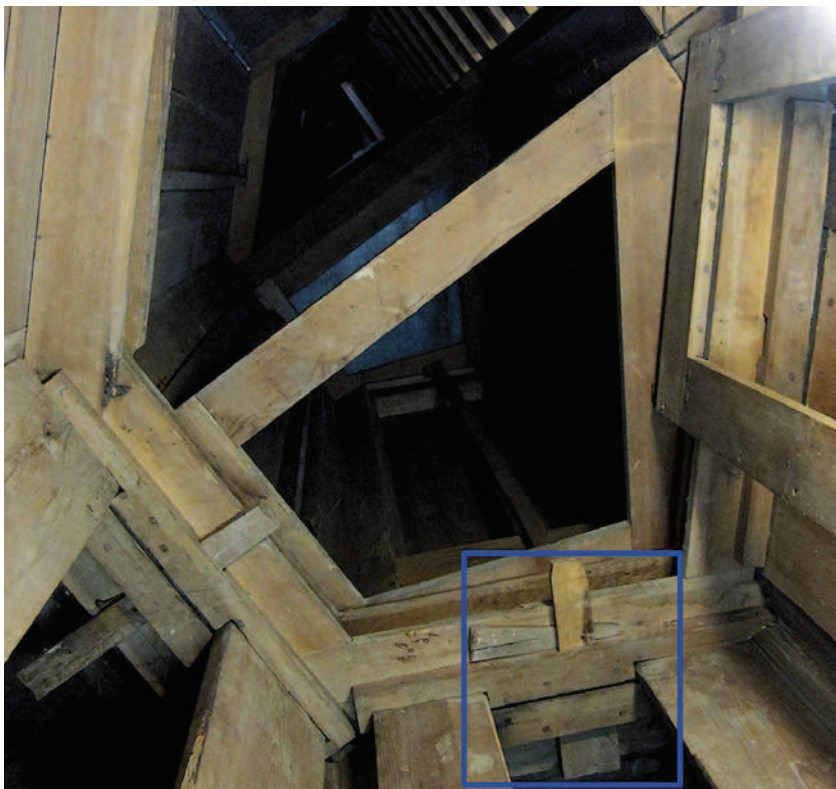
The in situ examination revealed that the 20th century treatments did not use the original locking system of frames, wedge mortises and tenon joints. Instead, the wooden parts were nailed and screwed into bearing and dormant parts without any respect and understanding of the baroque construction. The initial survey in 2008 reveals that 93% of the locking wooden wedges were missing. Additionally, extensive parts of the frames in the modules were absent.

8. A wedge mortise and tenon joint (blue colour) on a frame of a module inside the altarpiece. Photo: Disent AB.
