Tracing the making of the painted stone portal of Ryning Palace, Stockholm

Anna Henningsson and Alexandru Babos

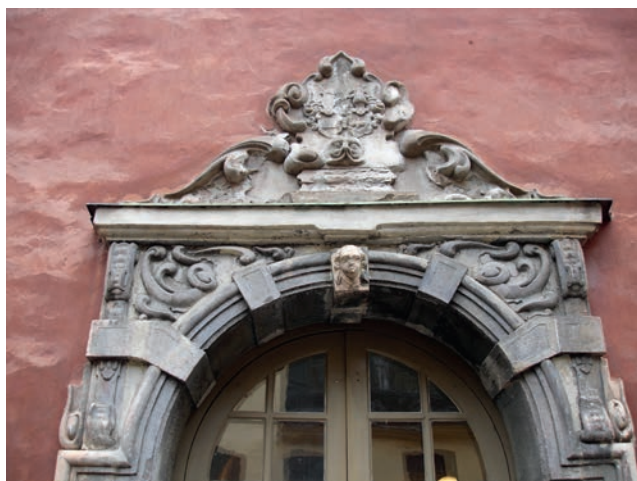
Figure 2 Upper part of the east port of Ryning Palace. The historic paint traces on the stone appear black or grey and are often not investigated prior to maintenance of the façade. (Photo: Anna Henningsson)

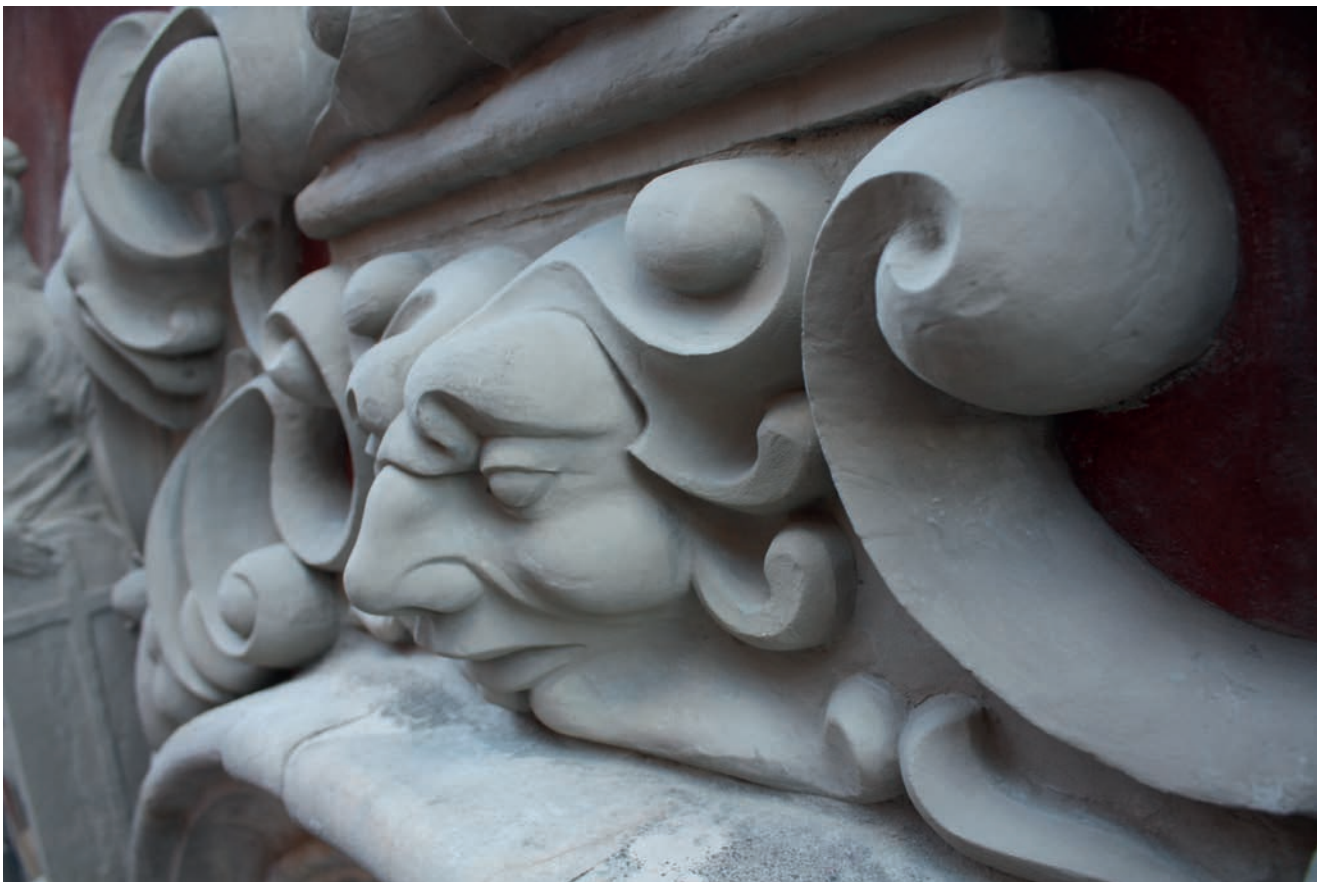
Figure 4 Ornament from the portal at the main street entrance of the main building that is attributed to a Dutch stonemason from Haarlem named Aris Claezon. (Photo: Anna Henningsson)

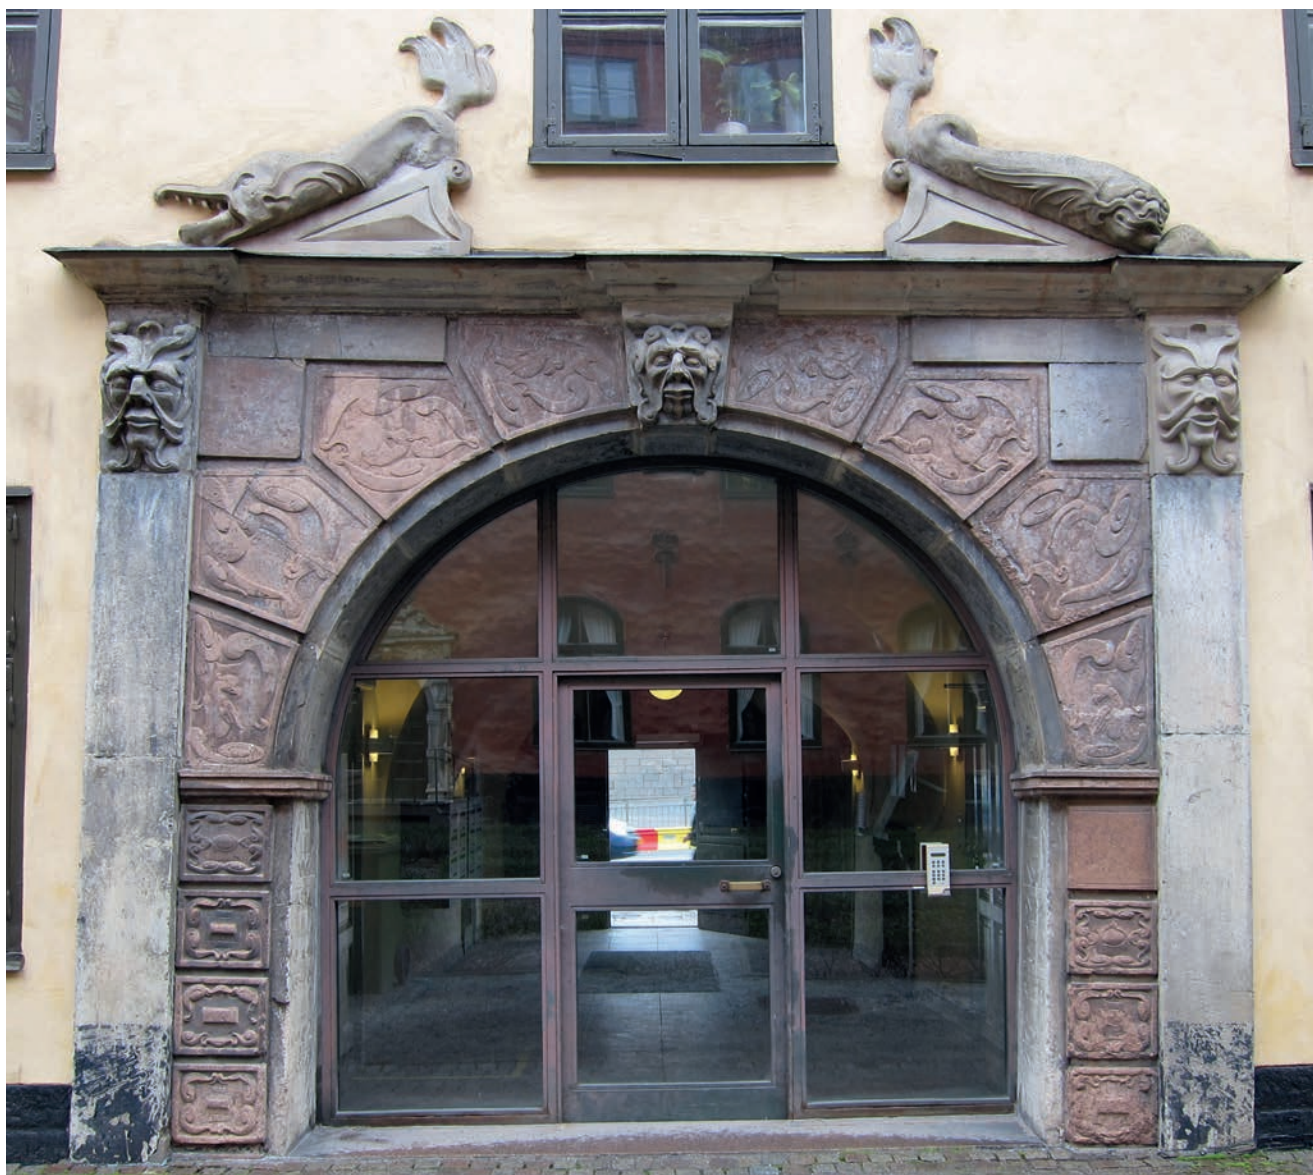
The site examination, with the aid of magnification under both normal and UV light, showed that the sandstone on the west portal was prepared before the first layer of paint was applied (Fig. 7). UV illumination revealed the presence of a preparatory layer of an oil medium, and it appears that the sandstone had been treated with oil before the application of the first layer of white ground followed by a white paint layer. FTIR showed that the first layer that was applied to the oil-treated sandstone contained calcium carbonate, silica and a small amount of lead white pigment in an oil-based binding medium. This first layer constituted the ground layer on the sandstone. The silica that was identified was in the form of fine aggregates for the lime ground. The low amount of lead white is an indication that this served as a siccative in this layer. In the following layer, lead white occurs as the only pigment in an oil medium.⁴ The strong interaction between the ground layer and the first paint layer as well as the absence

Figure 7 The west portal of Ryning Palace. (Photo: Anna Henningsson)

of a layer of dirt between these layers confirm that the first white layer can be dated to the 1640s. These findings strongly suggest that the sandstone on the west portal was intended to have a smooth, bright and shiny surface at the time it was built between 1640 and 1644. The appearance of a smooth surface is achieved by saturation of the sandstone with oil in combination with the application of a ground layer based on fine filler material such as calcium carbonate and silica. The use of a pure oil medium for the first paint layer (in combination with the preparation layers described above) would have created a glossy appearance.

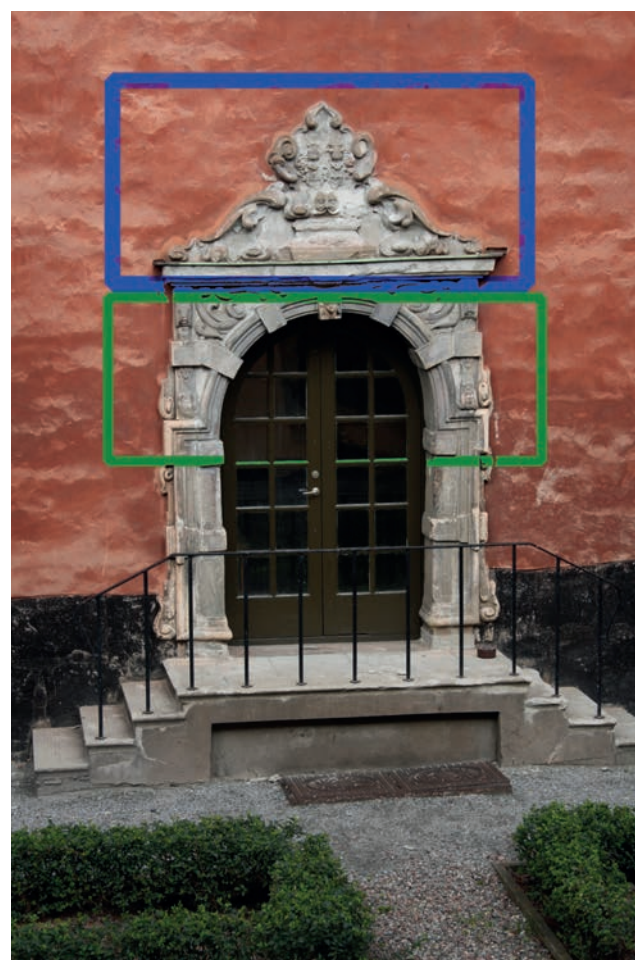
with microchemical testing indicated the presence of oil tempera and lime-casein in the binding medium. The conservation materials applied during earlier conservation treatments complicated the laboratory analysis of the sandstone parts of the east portal. The upper parts of the east portal (see the blue box in Figure 8) had been treated using an acrylic-based mortar and an acrylic-based glaze. The addition of these materials made it very difficult to produce any useful laboratory results because the acrylic material had consolidated the paint layer as well as the stone surface. Therefore, the investigation of the east portal focused on the stone in the central part of the portal (see green box in Figure 8). It was not possible to determine a complete colour scheme on this portal.

Figure 8. The east portal of Ryning Palace. The blue outline in the picture shows the area where it is extremely difficult to obtain valuable information from the paint traces due to conservation treatments based on acrylic. Therefore, the investigation of the east portal focused on the stone in the central part of the portal (green outline in the figure). (Photo: Anna Henningsson)
